Millstone Nuclear Power Station, Unit No. 2
Licensee Event Report 2000-001-00
Manual Reactor Trip Due to Secondary System Transient

LER 2000-001-00

Manual Reactor Trip Due to Secondary System Transient

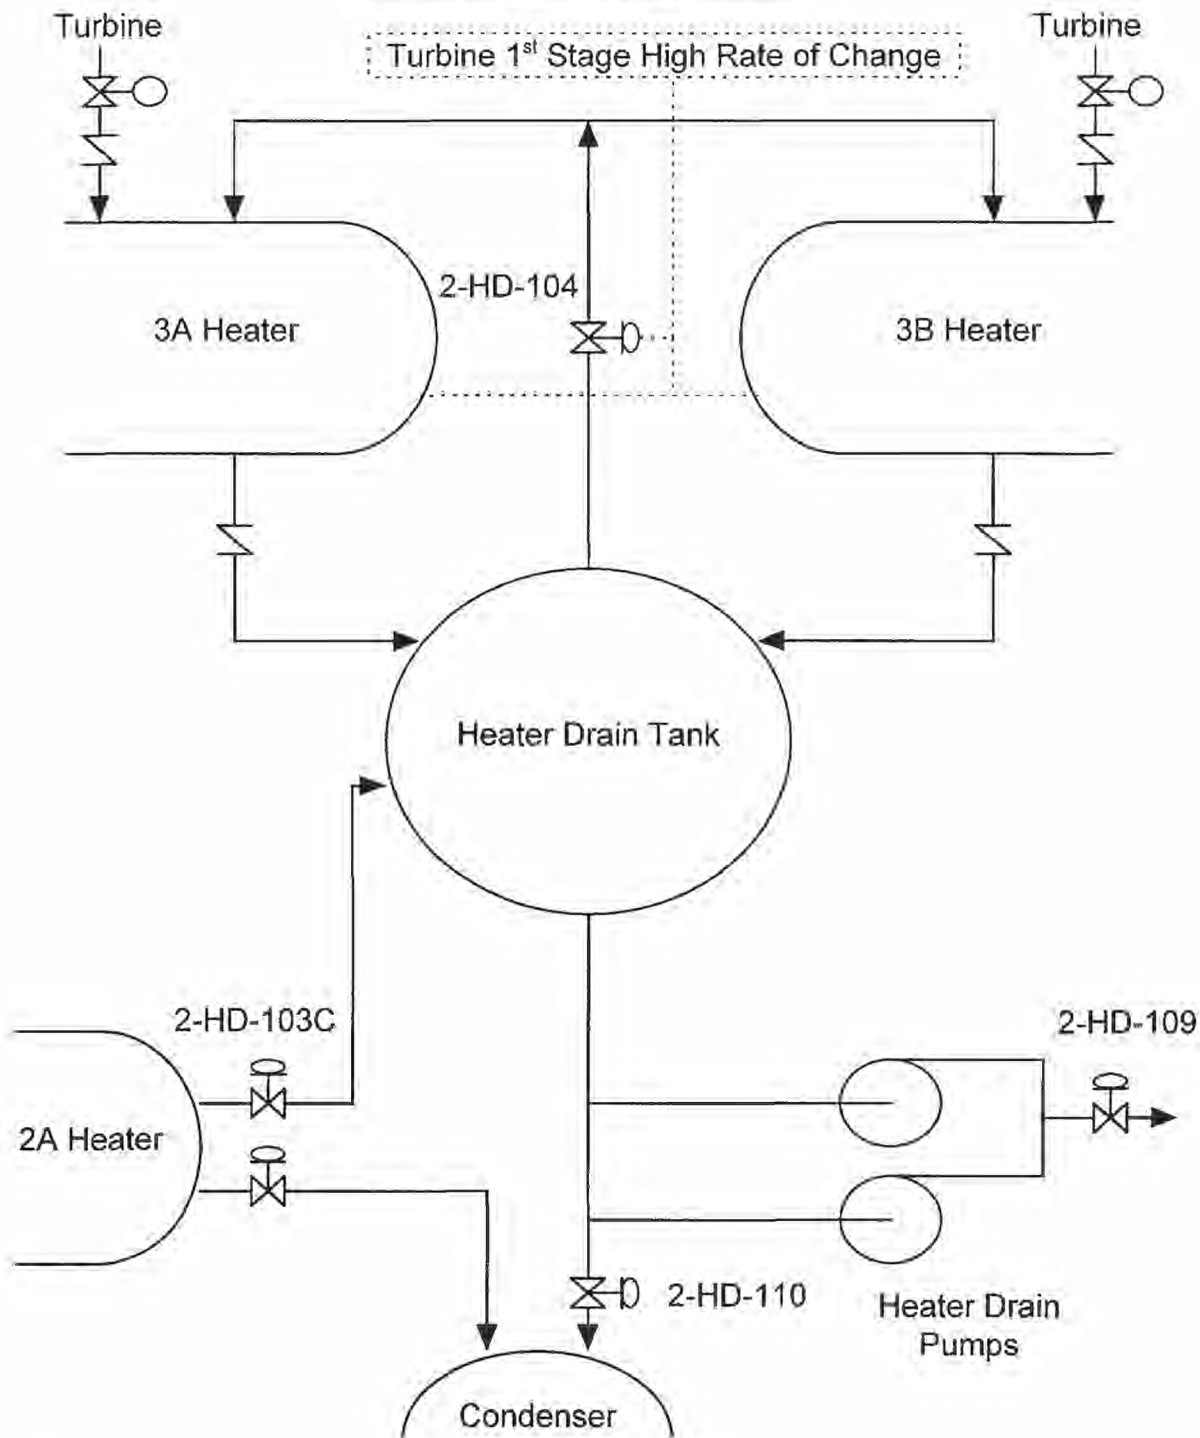
Figure 1

After post-trip analysis, it was determined that the transient was initiated following a leak repair and restoration of the 2A feedwater heater [HX] sight glass [LG] (see figures 1 and 2 for simplified arrangement sketches of the heater drain system [SM] and sight glass/level sensor). This action combined with a slow actuation of the 2A feedwater heater level control valve [LCV] 2-HD-103C, exacerbated the severity of the transient, resulting in a large volume of relatively hot water entering the heater drain tank [TK]. Heater drain tank pressure increased, stopping or reducing flow from the 3A/B feedwater heaters resulting in high level and automatic extraction steam valve isolation.

With extraction steam isolated to the 3A/B heaters, steam pressure in those heaters decayed approximately 30 psi over a short time period. During this period, the heater drain tank vent valve [VTV] 2-HD-104 to the 3A/B feedwater heaters remained open from the initiation of the transient until the main turbine [TRB] tripped following the reactor trip. This vent valve should have closed upon receipt of either the 3A or 3B heater high level alarm. With the vent valve open and extraction steam isolated, the 3A/B heaters condensed steam from the heater drain tank and caused a rapid depressurization of the tank. Because conditions in this portion of the feedwater heater system are near saturation conditions, the sudden loss of pressure caused the water in the heater drain tank to flash to steam which ultimately resulted in a loss of net positive suction head to the heater drain pumps and loss of heater drain flow to the SGs. Shortly thereafter, SG feed pump suction pressure decreased and resulted in a SGFP trip. As level in the SGs began to decrease, the primary plant was manually tripped.

It was determined that this event was caused by the loss of all heater drain flow to the suction of the SGFPs as a result of bulk flashing in the heater drain tank. As event precursors, it was determined that the transient was initiated due to the restoration of the 2A feedwater heater's sight glass causing oscillations in the feedwater control system that adversely affected the systems' ability to recover from the transient. Also, it was concluded that the heater drain tank vent control valve 2-HD-104 control logic wiring did not permit the valve to function properly in order to mitigate the consequences of a loss or rapid reduction of extraction steam pressure on the heater drain tank.

1. The feedwater heater system performance was optimized by improving the stroke time for the level controller valve.
2. The control logic for 2-HD-104 has been corrected such that the valve will close to prevent depressurization of the heater drain tank.
